Performance Degradation of Grid-Tied Photovoltaic Modules in a  
Desert Climatic Condition

A Thesis Presented in Partial Fulfillment  
of the Requirements for the Degree  
Master of Science in Technology

ARIZONA STATE UNIVERSITY

December 2010

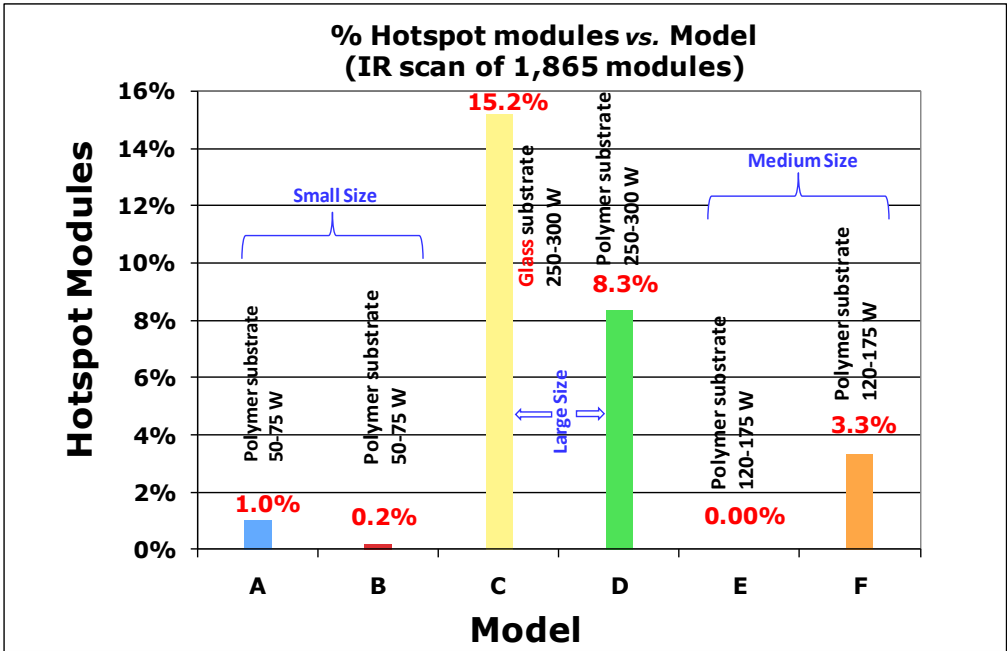
Figure 26. Breakdown of hotspot modules by model

(All are glass/polymer modules except “C” which are glass/glass modules)

It is immediately obvious that Model C has the highest percentage of hot spots. It is believed that the thermal stress of the glass/glass construction and large size could be primary causes for this failure type. The second highest percentage of hot spots is found in Model D. Model D was also made of large size modules. As expected, the large size modules are more susceptible to thermal expansion and contraction of cell components including interconnects, superstrate/substrate and frames. Higher thermal expansion and contraction is expected to lead to higher hotspot issues.

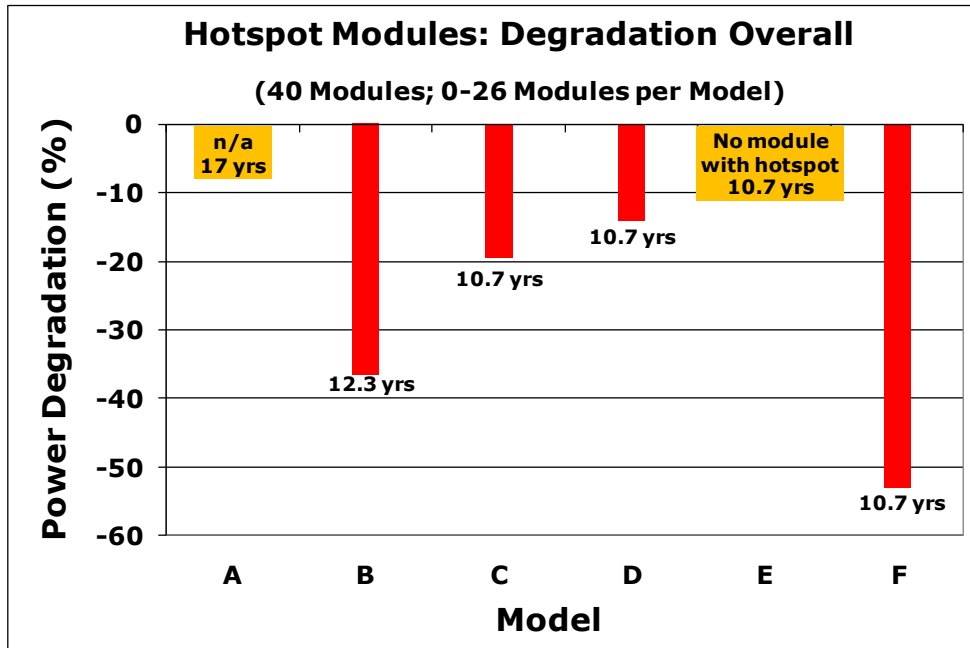
Figure 28. Degradation of hotspot modules (all years)

Figure 28 shows the average power drop from the nameplate rating of the models. There does not appear to be any discernable correlation between the age and extent of hotspots. The modules of Model C (10.7 years old) experienced about 15% (highest) hotspot occurrences and

about 19.5% power degradation whereas the modules of Model F (10.7 years old) experienced only about 3% hotspot occurrences but about 53% power degradation. This indicates that there is no direct correlation between hotspot severity, age, and power degradation unless the location/type of hotspot is sensitive to power generation issue (rather than safety issue). It seems that the hotspot modules of Model A are a special case. According to the data obtained from the I-V curve tracer, the power output of Model A had no power drop over the 17 years of fielding. Not knowing if it was human error during measurements by test personnel or labeling/binning (mixing higher power binned modules with lower power binned modules) by the manufacturer, it is felt that these findings deserve further attention and further study. These results will not be discussed in the remainder of this report.

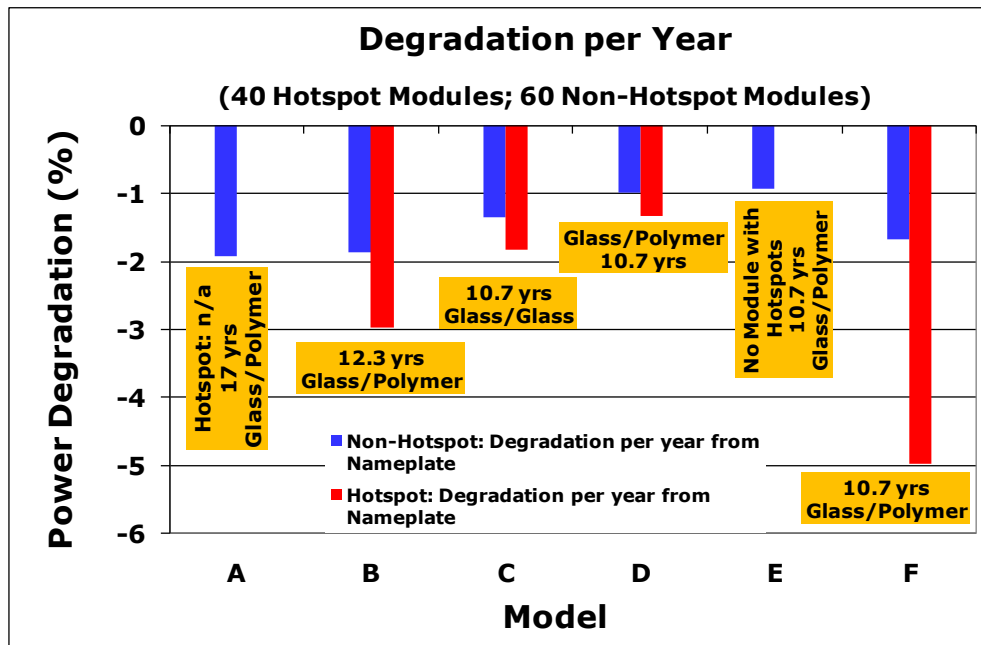
Figure 30. Degradation rate of hotspot and non-hotspot modules (per year)

To delve further into the annual degradation rates, one can notice that the annual degradation rates obtained in this study are higher than those previously reported. In a study performed by NREL [9] in Golden, Colorado, different modules were individually held at maximum power to study degradation. From the NREL and other module level long-term studies performed at ASU, it is seen that the crystalline silicon PV modules degrade at less than 0.5% per year. However, from the current study one could determine that c-Si modules degrade between -0.93% and -1.92% per year. This significant difference in degradation rate may lie in the system voltage levels, module mismatch and insolation levels (1-axis vs. fixed-tilt) of the systems investigated in this study.

The OPV 1 and OPV 2 systems consist of a large number of modules connected in series. This series connection brings about two possible issues for the increased degradation rate: a system voltage of 400V and module mismatch. When modules are connected in series they must all have equal current outputs, if not, a bottleneck effect can occur in the module with the least current output. This bottleneck effect causes the module to dissipate the backed up current as heat energy, degrading the module.

In regards to the high system voltage, the high voltage can reduce the effectiveness of the encapsulant dielectric properties allowing a slight leakage current between the cells and frame/grounding. This leakage current comes out of the photovoltaic cells causing an electrochemical corrosion of cell components (especially metallic components) at the interface between the cell and encapsulant. The electrochemical corrosion becomes photoelectrochemical corrosion in the presence of sunlight and it is known to be much worse than simple chemical or electrochemical corrosion. Neither (high voltage and mismatch) of these effects can take place unless the module is connected in series such as in the case of a system composed of large arrays studied in this project.
